**Detailed Site
Investigation**

Phillip Drive, South West Rocks, NSW, 2431

ECON Environmental Pty Ltd
12 October 2022

AU122217 Final R01

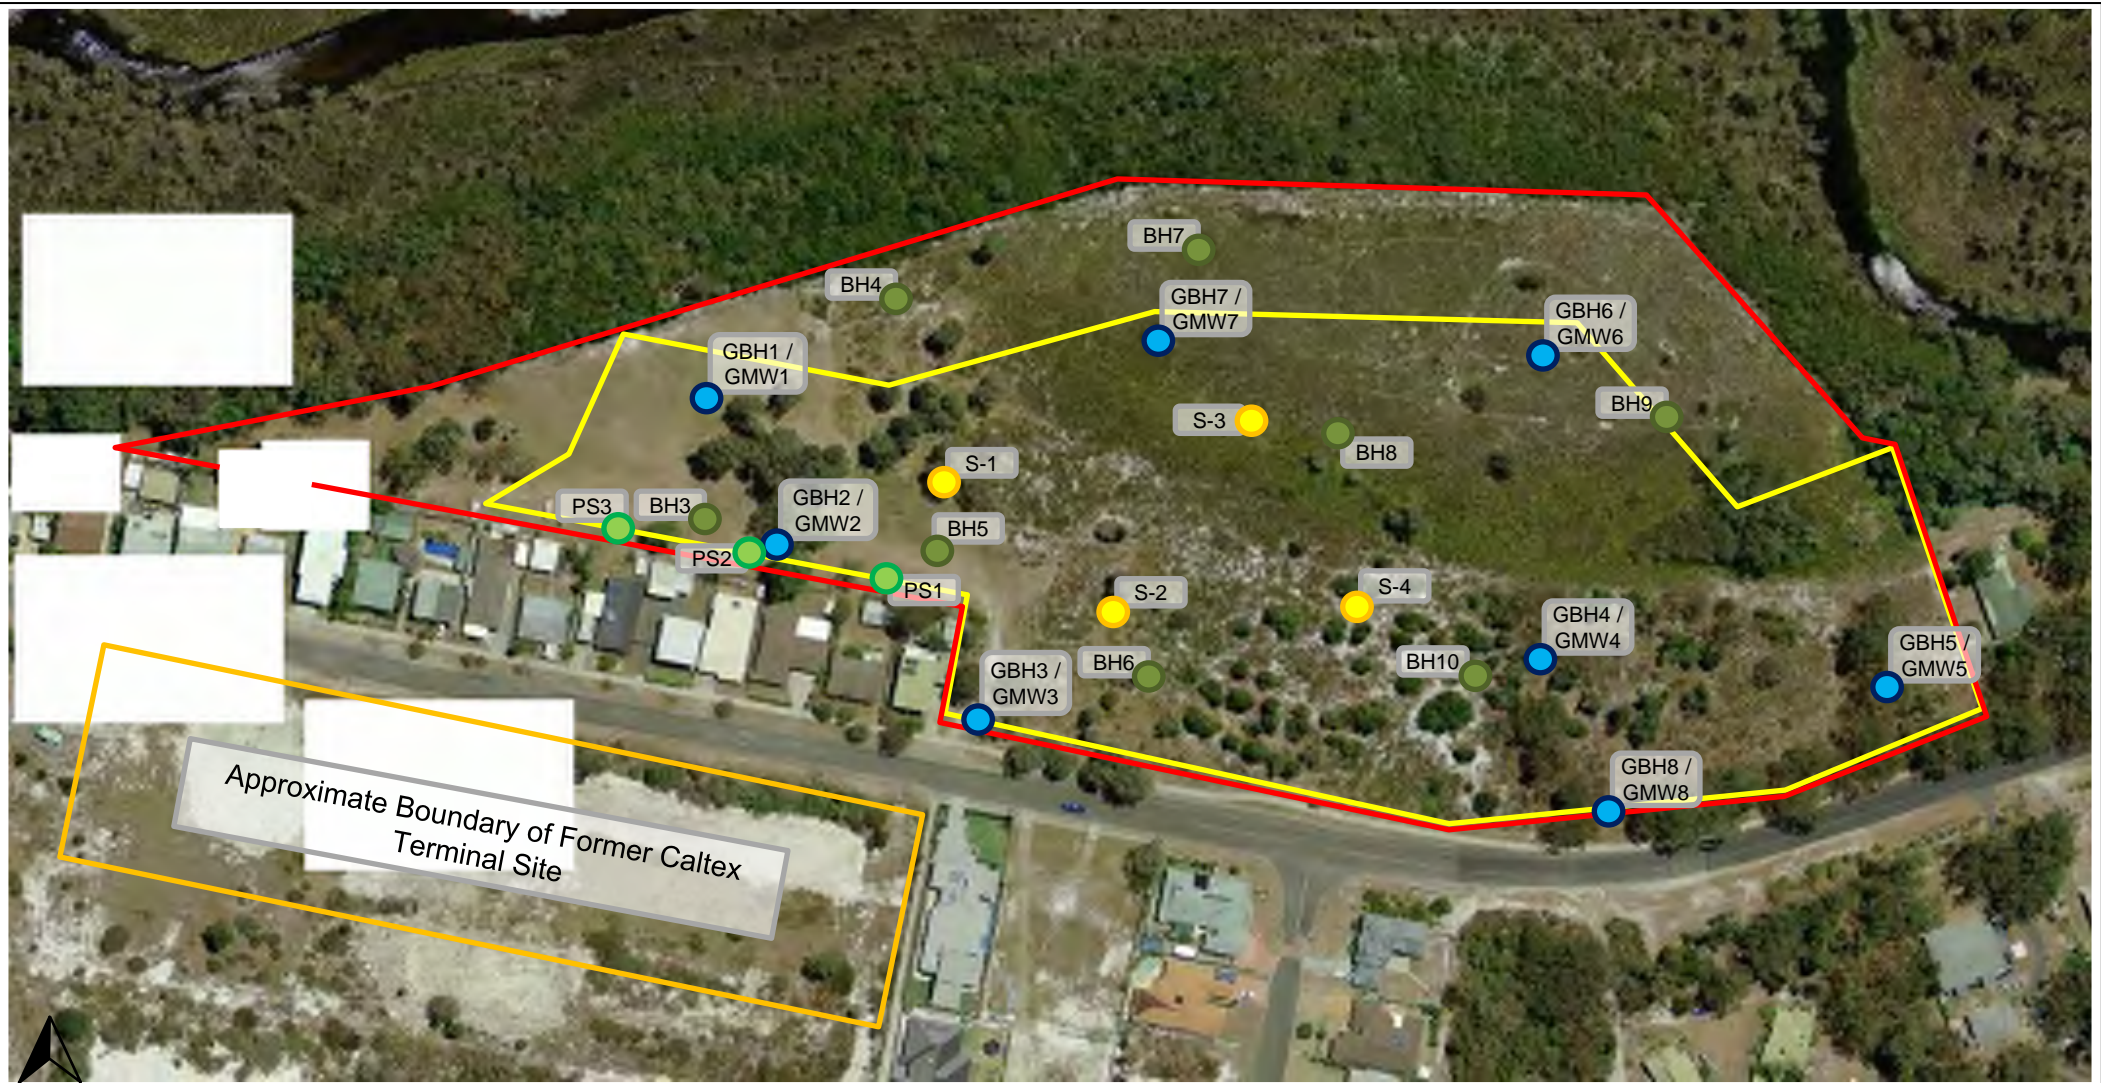
- ▭ Approximate Site Boundary
- ▭ Approximate Footprint of Stage 1 Development Impact
- Geosyntec (2022) Borehole / Groundwater Well Approximate Locations
- Geosyntec (2022) Shallow Soil Sample Approximate Locations

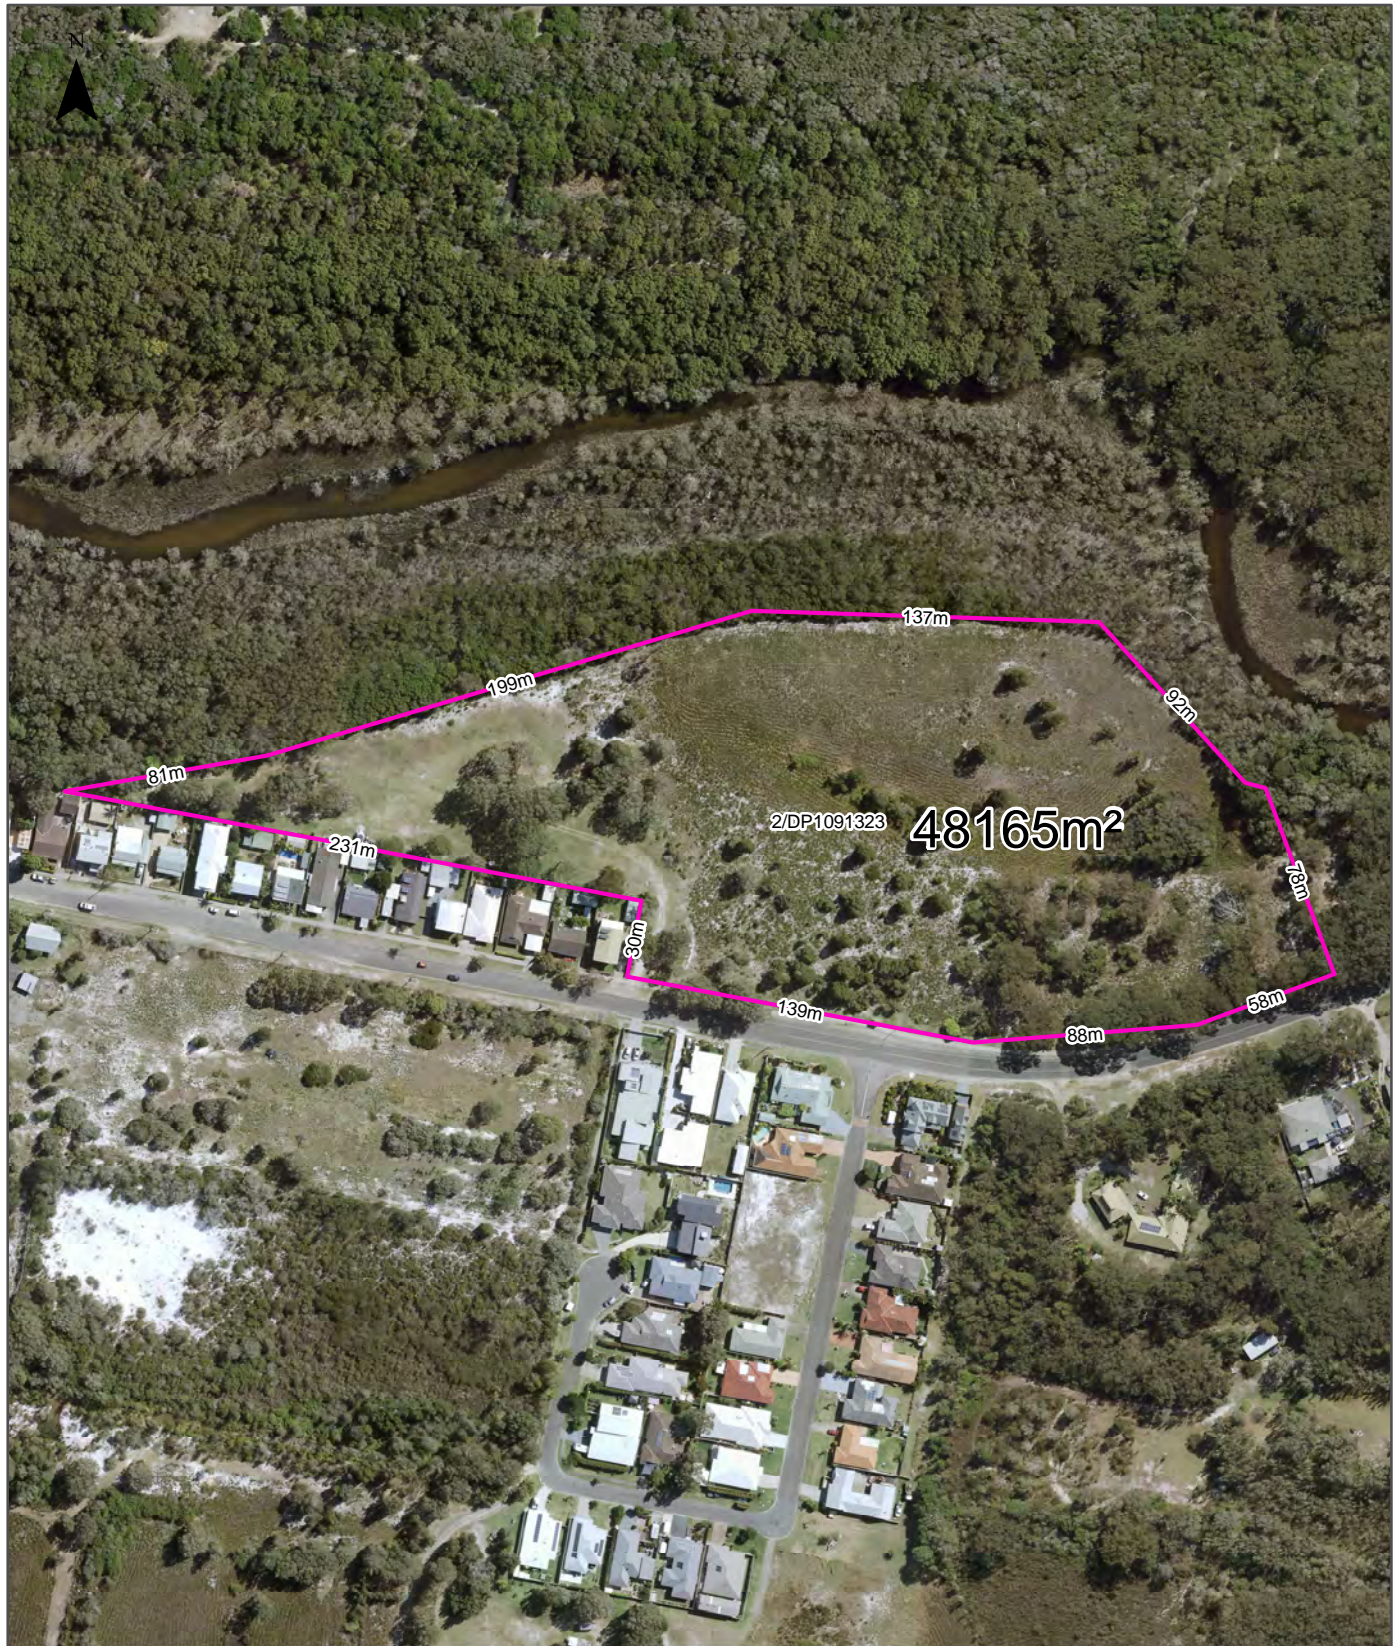
Site Diagram

<p>Legend</p> <ul style="list-style-type: none"> Site Boundary Internal Parcel Boundaries 	<p>Total Area: 48165m²</p> <p>Total Perimeter: 1.13km</p> <p>Disclaimers:</p> <p>Measurements are approximate only and may have been simplified or smaller lengths removed for readability.</p> <p>Parcels that make up a small percentage of the total site area have not been labelled for increased legibility.</p>	<p>Scale:</p> <p>Data Source Aerial Imagery: © Aerometrex Pty Ltd</p> <table border="1" style="width: 100%;"> <tr> <td style="width: 50%;">Coordinate System: GDA 1994 MGA Zone 56</td> <td style="width: 50%;">Date: 27 May 2022</td> </tr> </table>	Coordinate System: GDA 1994 MGA Zone 56	Date: 27 May 2022
Coordinate System: GDA 1994 MGA Zone 56	Date: 27 May 2022

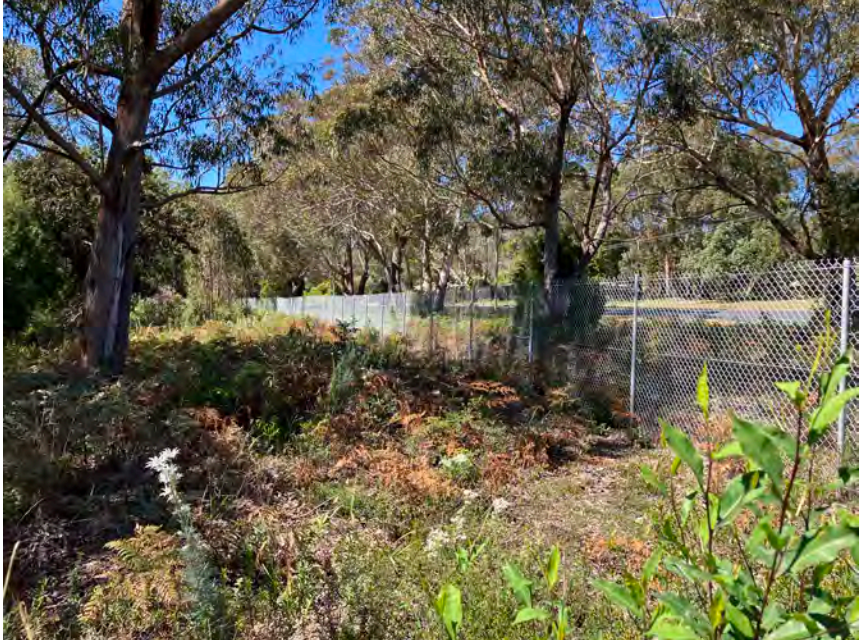
<p>Photo Number: 11</p>	<p>Date: 6/09/2022</p>

<p>Description: South-eastern boundary of the site.</p>

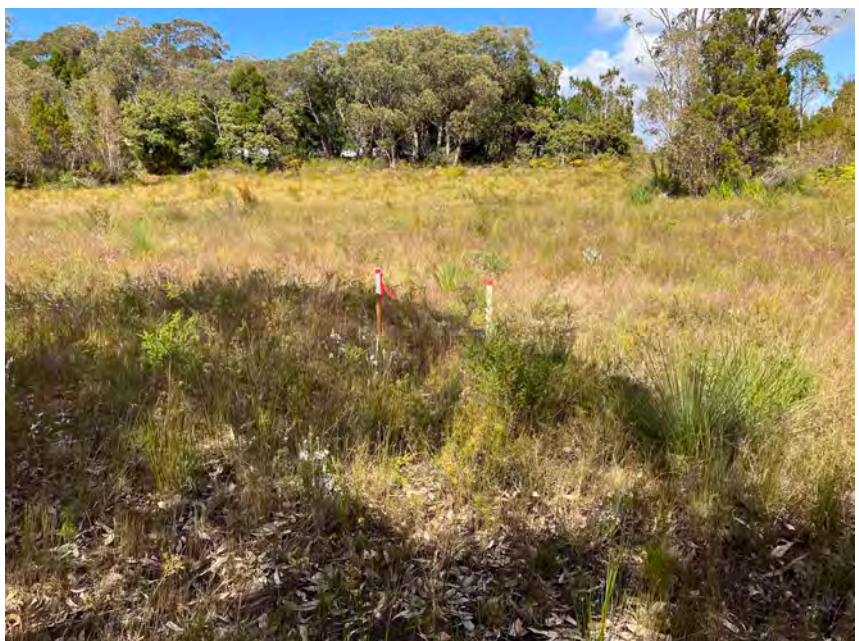
<p>Photo Number: 12</p>	<p>Date: 6/09/2022</p>

<p>Description: View to the south across the eastern portion of the site, with GMW6 in foreground.</p>
